Royal River Rolling Stones Project

Factory Island Back-Channel, Yarmouth - 2012

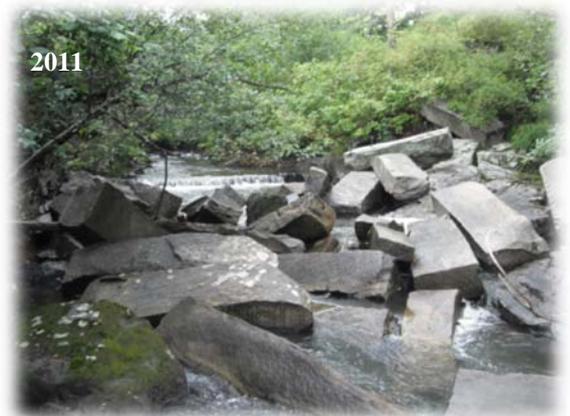
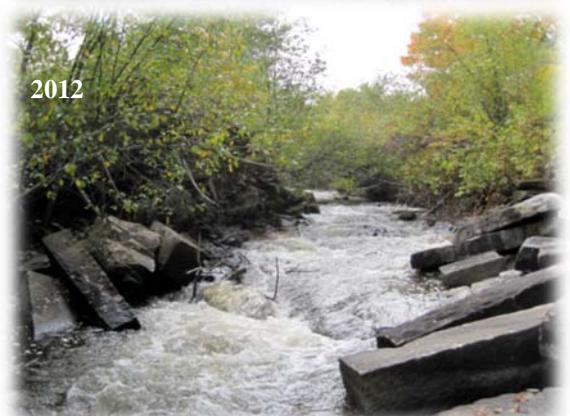
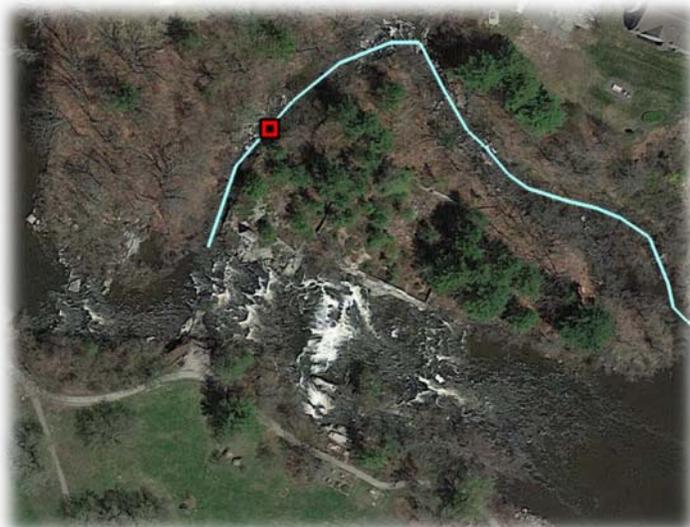
The structure over Factory Island back-channel in 2008 (top), 2011 (middle), and 2012 (bottom).
