Yarmouth's Royal River Fishways

Frequently Asked Questions

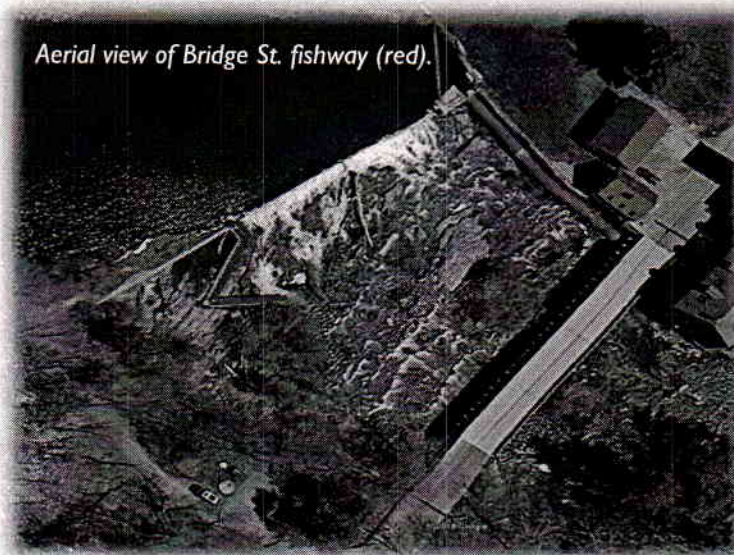
Aerial view of Bridge St. fishway (red).

Bridge St. dam fishway - In addition to needing repairs & maintenance, constraints include:

- ◆ Does not meet the current design standards for shad (too steep and narrow, with too many sharp bends)
- ◆ Lacks juvenile eel passage (for spring migration)
- ◆ Lacks intentional downstream fish passage (increasing injury/death during outmigration)
- ◆ Is inadequately sized to meet standards for anticipated run populations, and for resting pool areas
- ◆ Competes with hydropower operations at Sparhawk Mill, attracting fish to the mill outflows
- ◆ Provides insufficient attraction flow at fishway entrance, competing with flow dispersed over the ledge falls

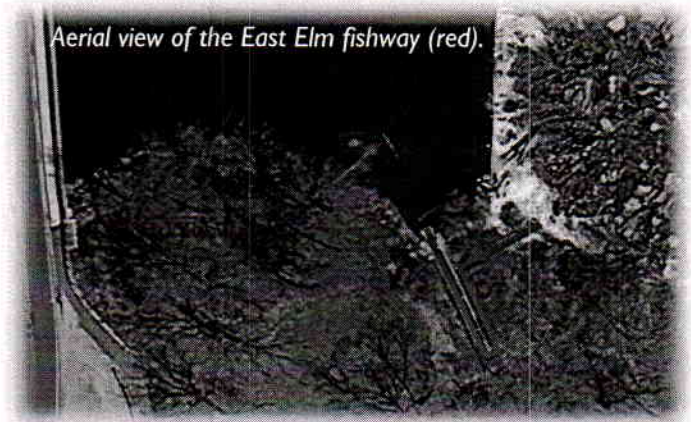
Aerial view of the East Elm fishway (red).

E. Elm St. dam fishway - A complete rehabilitation would be needed to regain operability and functionality, including replacement of weirs, gates, trash racks & control structures. Additional constraints:

- ◆ Entrance is blocked with boulders, & adjacent channel requires modification
- ◆ Entrance configuration is very poor, with water flowing across the entrance
- ◆ The stop log weir is in disrepair and blocked with debris, negating its use in managing flow
- ◆ Outflow from the foundry by-pass channel forms a competing attractant flow
- ◆ Does not meet the current design standards for shad (too steep and narrow, with too many sharp bends)
- ◆ Lacks juvenile eel passage (for spring upstream migration)
- ◆ Lacks intentional downstream fish passage (increasing injury/death during outmigration)
- ◆ Inadequately sized to meet standards for anticipated run populations, and for resting pool areas
- ◆ Provides insufficient attraction flow at fishway entrance, competing with currents dispersed over the ledge
